## Interference, Modems and Satellite Links (rev 1)

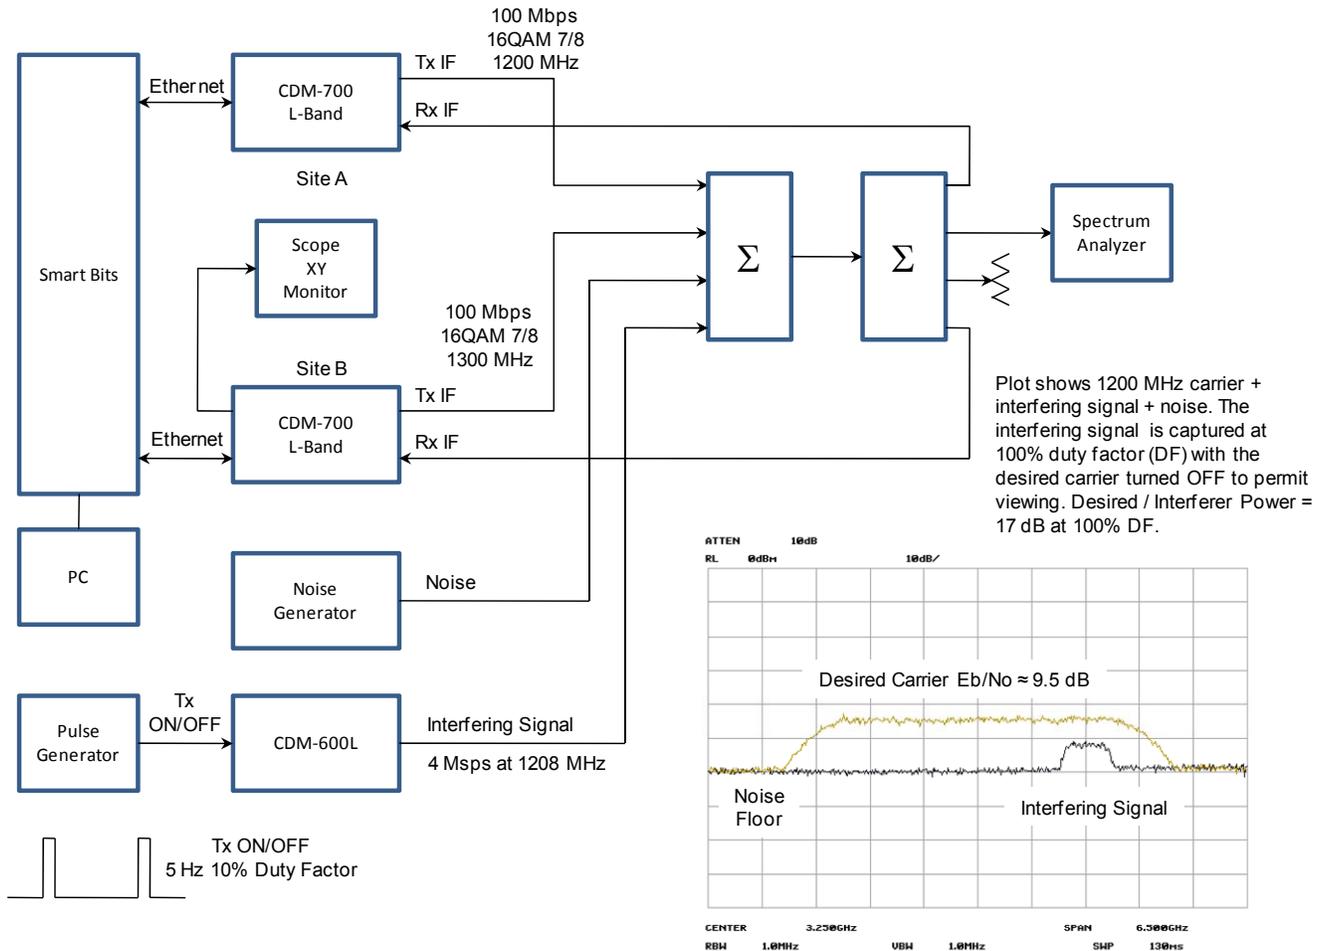
**Figure 1 Test Setup for Interference Testing**

A test setup was constructed to model a link with an interferer that produced the symptoms described in the previous section. **Figure 1** simulates a link with two CDM-700s, and then adds an interfering source to create the symptoms. The setup was run in both directions at 100 Mbps with 7/8 16-QAM, because this is the configuration experiencing degraded performance.

The jammer uses a CDM-600L modem transmitting a 4 Msps carrier. The CDM-600L transmitter is turned ON/OFF using a pulse generator to activate the EXT carrier control available on the Alarm Connector at the rear of the unit. Transmitting the Tx IF interfering carrier with a 10% duty factor (DF) allows the CDM-700 to report the  $E_b/N_o = 9.5$  dB, and FPGA link errors occur regularly.

The desired carrier is centered at 1200 MHz and the jammer is placed at 1208 MHz. The jammer is far enough below the desired carrier that it is not visible when viewed with a spectrum analyzer. A duty factor of 10% results in insignificant degradation of  $E_b/N_o$  and a barely noticeable impairment to the IQ constellation display. The FPGA link error counter increments because the bursts from the interfering signal corrupt the HDLC wrapper carrying the Ethernet packets over the link.

The Desired / Interferer ratio is 17 dB when the duty factor is 100%. The average power is 10 dB less when the duty factor is 10%, so the jammer is 27 dB below the desired carrier. Clearly, the instantaneous bursts are enough to corrupt the packets transported by the desired carrier.

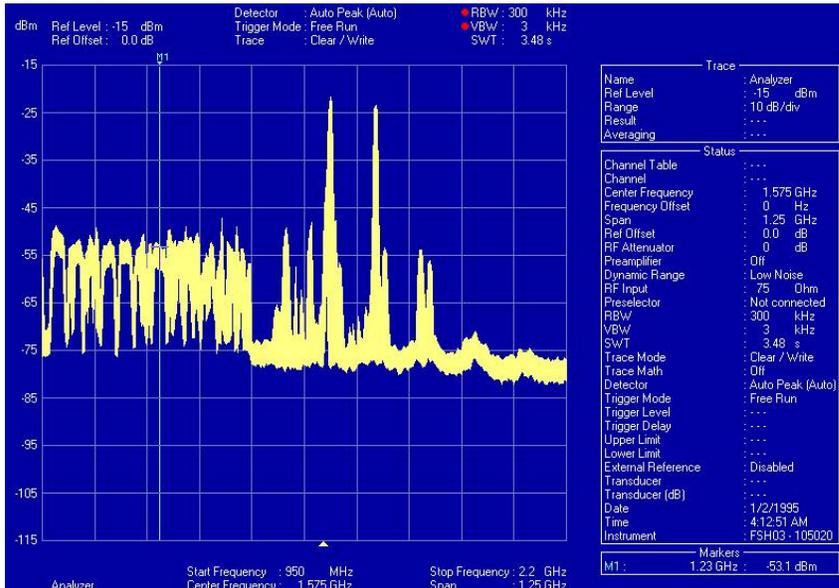
<b>WiMax – actual problem at 3400 MHz.</b>	The two interfering signals are 25+ dB above the desired carriers and are terrestrially-based. They reached a sufficient level to pass through the antenna and LNB at 3400 MHz and drive the LNB nearly to saturation.
<b>This is a serious problem even though the interference is located outside the satellite band, because the level is so high and the RF front end is broadband.</b>

<p>This problem was solved with a low-loss filter between the antenna and LNB to reject the out-of-band energy.</p>
